1 **Engineering Lessons from the 28 September 2018 Indonesian Tsunami: Scouring**
2 **Mechanisms and Effects on Infrastructure**

91 A reconnaissance team led by the Waseda University, Japan, consisting of members
92 from Japan, USA, Indonesia, Canada and Germany, visited Palu Bay from the 27th to 31st
93 of October 2018. The objectives of this post-tsunami survey were to investigate the tsunami
94 generation mechanisms, to collect data concerning the flooding extent, and to reveal
95 knowledge gaps in tsunami-driven structural failure modes. The present work focuses on
96 the hydrodynamic loading and scouring around structures, comparing them with recent
97 tsunami design practices. The ultimate goal is to provide insights that tie knowledge from
98 the post-hazard survey to current design standards, and to specifically elucidate relevant
99 knowledge gaps pertaining to soil instability uncovered during the literature review, field
100 campaign, and analysis.

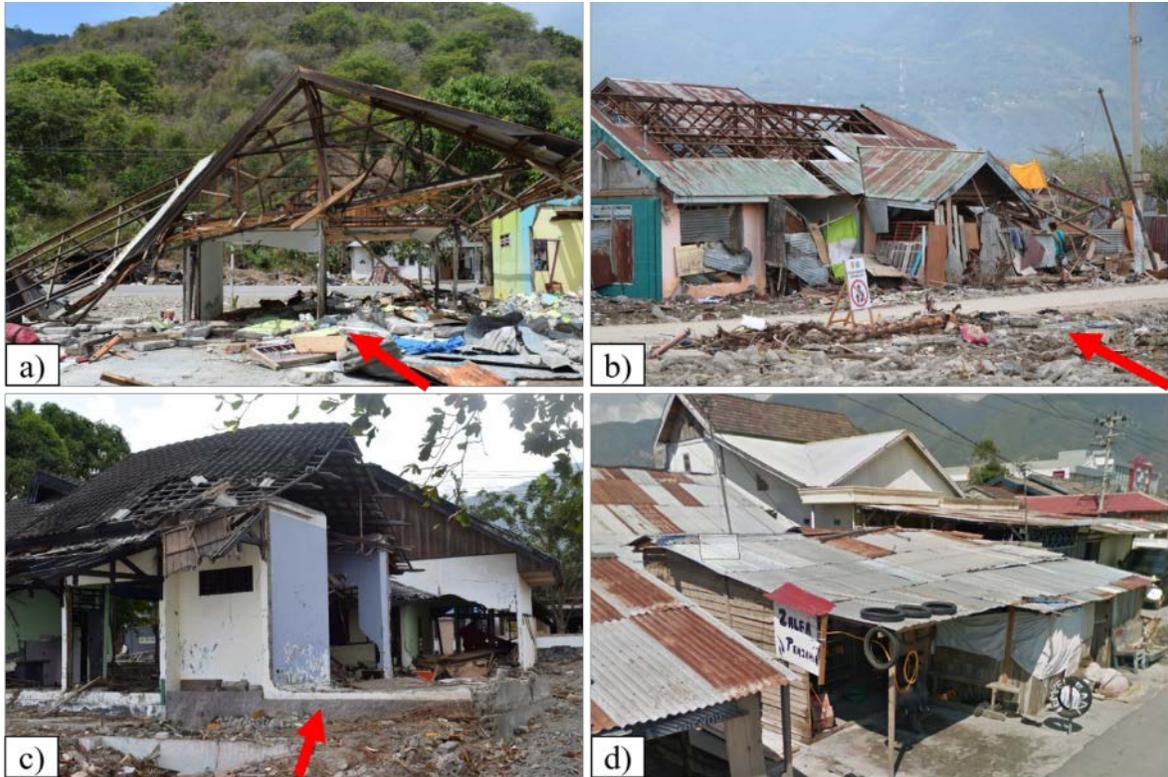
328 Residential buildings in the Palu area have a variety of construction designs, with Figure 5
329 showing typical light timber constructions, some of which had concrete frames filled with
330 masonry walls or metal sheets (Figure 5 b). Some buildings were constructed out of
331 reinforced concrete, and exhibited greater stability. Many timber constructions and masonry
332 infill walls failed due to tsunami loading (Figure 5 a-c) while solid concrete frames were
333 mostly able to withstand the tsunami impact.

335 *Figure 5: Typical buildings in Palu City with red arrows indicating the approximate direction of the incoming wave.*
336 *Pictures a-c) show damaged or demolished buildings, as observed during the post-tsunami survey, while d) is a picture*
337 *obtained from Google Earth of a simple timber structure in Palu City which was washed away.*

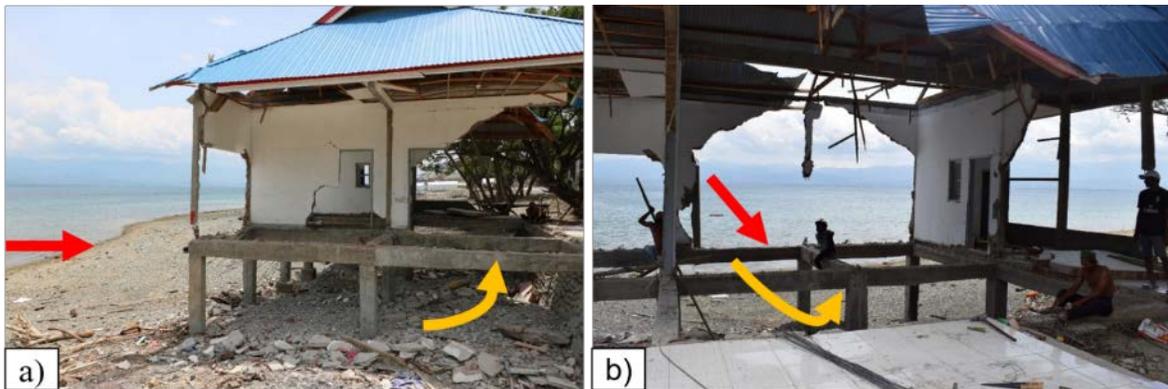
360 Loli Pesua is a small town located 15 km north-west of Palu City. A road situated 2-
361 3 m above sea level traverses the town at a distance of 20 to 50 m from the coastline. The
362 tsunami run-up height at this location was measured to be 3.9 m (Omira et al. 2019). A site-
363 cast concrete building located on the leeward side of the road was affected by the tsunami, see
364 Figure 7. A retaining wall and two rows of concrete columns, each with four columns
365 (0.3 m × 0.3 m × 2.1 m) parallel to the shoreline, supported the building. Reinforced
366 concrete was used for the frame elements whereas the walls and slab consisted of masonry
367 infill. The frame elements withstood the tsunami impact, though vertical uplift forces on the
368 bottom slab were induced by the incoming tsunami, as its progress was impeded by the
369 retaining wall.

371 *Figure 7: Site-cast concrete building in Loli Pesua. a) View of the building from the beach and b) showing the destruction*
372 *to the slab. Red arrows indicate the incoming tsunami flow direction, while yellow arrows indicate the likely flow path*
373 *under the building.*

418 simultaneously (with this load combination probably causing the failures shown in Figure 7
419 and 8). The uplift forces caused by a tsunami bore flow that is blocked by solid walls are
420 considered in ASCE 7-16 Chapter 6 (2017), as mentioned earlier. The uplift pressure
421 depends on the ratio of slab soffit elevation to flow depth. Robertson (2014) compared
422 small and large scale experiments concerning uplift forces on slabs with a solid wall
423 blocking the tsunami bore flow behind the slab, showing that maximum uplift pressures of
424 up to 1.4 times the maximum design pressure for ratios of slab soffit elevation to flow
425 depth of 1.0 to 1.5. This maximum might be related to pressure shocks by entrapped air,
426 which is not considered explicitly in ASCE 7-16 Chapter 6 (2017). The investigation of
427 load combinations leading to uplift as a consequence of highly turbulent tsunami flows

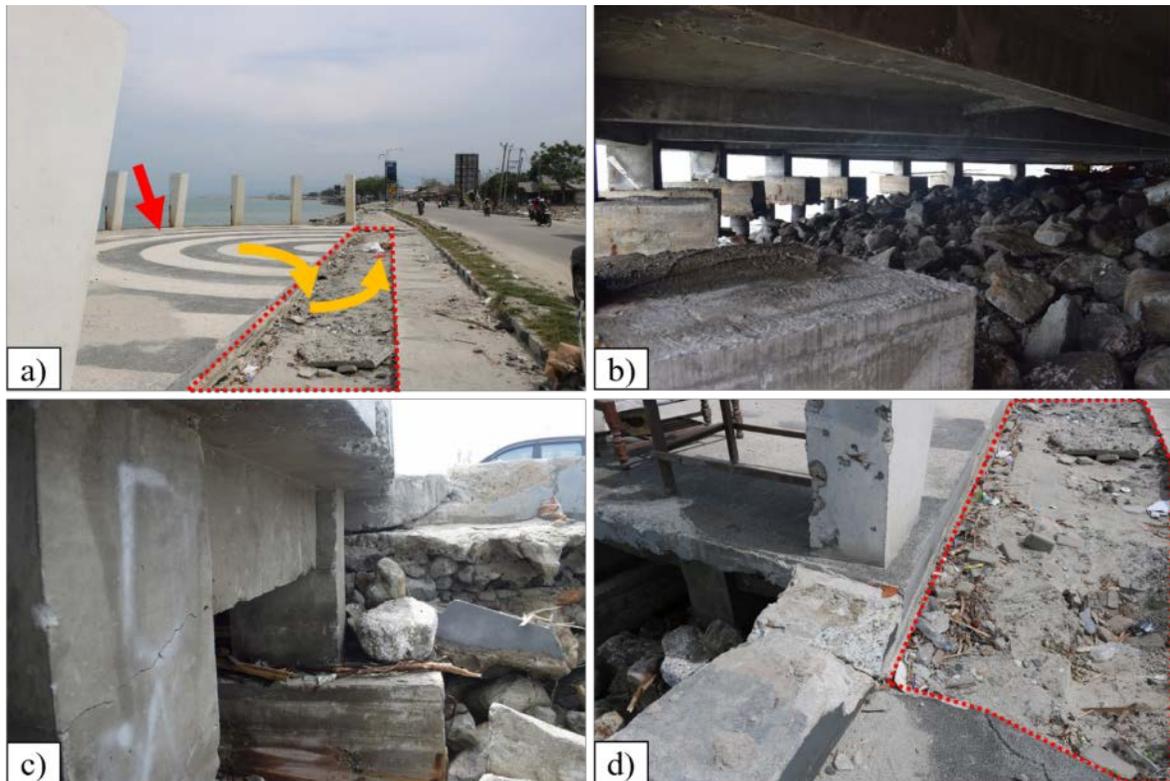
374 Figure 8 shows the Pavilion at Talise Beach on the east side of Palu City, which
375 serves as a lookout over the bay and is located directly on the coastline, roughly 1 m above
376 sea level. Twelve foundation piles and a retaining wall support the slab. Radial joists
377 directed towards the centre of the semicircle-formed slab connected the piles. Ruptures
378 along the concrete columns indicate that vertical uplift forces were induced due to the

379 tsunami flow entrapped in the wall-slab recess, a situation very similar to what was
380 observed at Loli Pesua.

382 *Figure 8: The Pavilion located on the east side of Palu City overlooking Palu Bay in a-b). c) Vertical uplift damage was*
383 *observed through cracks in the piles and in the rear anchoring and d) in the aesthetic tiling. Areas of interest are*
384 *highlighted by arrows and dotted lines to indicate uplifted tiles and erosion.*

385 Damage to both structures seems to have been enhanced by the construction
386 methodology, with a bottom slab placed above joists in front of a retaining wall. This
387 phenomenon of tsunami flow entrapped in structural wall-slab recesses is considered by
388 ASCE 7-16 Chapter 6 (2017) for incoming bore conditions, but no guidance is provided for
389 non-bore (surge) conditions due to the lack of experimental data (Ge and Robertson 2010).
390 Given that the obstructed flow may have developed during the initial approach of the
391 tsunami, it is very likely that a pressure imbalance between hydrostatic and hydrodynamic
392 components led to forces acting in the vertical direction. The uplift force could have moved
393 the slab slightly upwards, as ruptures were found along the concrete columns and at the

394 anchoring to the retaining wall. ASCE 7-16 Chapter 6 (2017) requires that slabs associated
395 with these slab-wall recesses be designed for an uplift pressure of 16.76 kPa (350 psf),
396 which would explain the damage observed in these two survey cases.

397 Inland from the lookout, a two-part sidewalk was found consisting of concrete slabs
398 (Figure 8 a, d). The first row (located behind the lookout step) was heavily damaged and
399 had been transported away, while the second row remained almost unaffected. Water
400 pressure passing the elevated slab may have contributed to uplift of the sidewalk as well as
401 negative pressures due to surpassing flow over the elevated slab. A comparable geometry to
402 investigate separation and reattachment of surpassing flows is the backward-facing step,
403 which has been extensively analysed. This case is often used as a reference for numerical
404 simulations to evaluate the representation of flow phenomena using a simple geometry
405 (Eaton and Johnston 1981, Le et al. 1997, Ratha and Sarkar 2015, Chovet et al. 2018, Wang
406 et al. 2019). Adams and Johnston (1988a, 1988b) found the flow between the wall and the

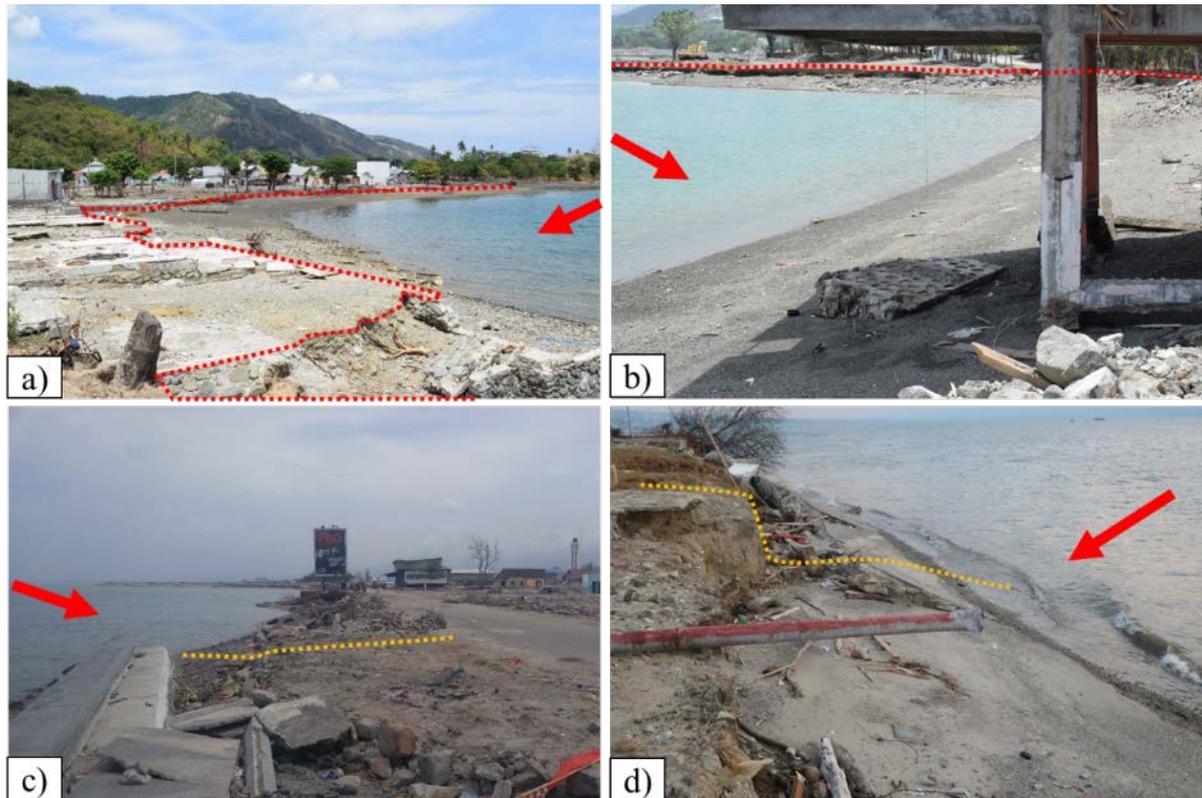
446 *Figure 9: Eroded areas were found on a) the west coast in Loli Pesua, b) in Watusampu. On the east side of Palu Bay*
447 *general erosion was observed in c) near the landslide north of Talise and d) at the Mamboro fuel station. Red arrows*
448 *indicate the flow direction of the incoming tsunami, red dotted lines show the erosion extent while yellow dotted lines*
449 *show the approximate slope indicating discontinuities.*

450 General erosion was found to be accompanied by local discontinuities in the soil
451 matrix, which was observed both on the west coast (see Figure 9 a, b) and on the east coast
452 (Figure 9 c, d) of Palu Bay. Strong discontinuities in the soil matrix were observed at
453 widely-graded soil compositions both in Loli Pesua (Figure 9 a) and at the Mamboro fuel
454 station (Figure 9 d). Narrowly-graded soil compositions were found in front of the
455 discontinuities with larger depths of general erosion. ~~While the erosion at the west coast~~

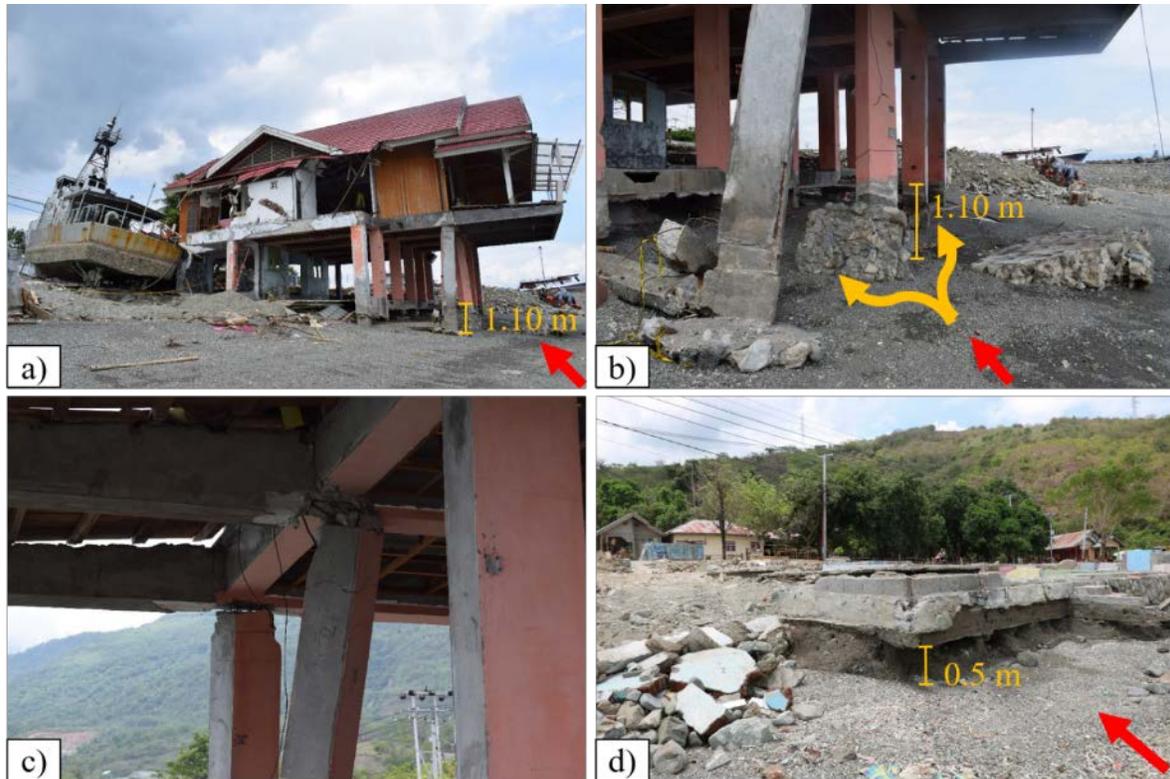
466 Four reinforced concrete columns in a building near Watusampu Naval Base were damaged
467 as a result of sustained flow scour around their foundations, as seen in Figure 10 a-c). All
468 four columns were supporting a balcony, and were 0.5 m in length and 0.35 m in width.
469 Gravel material supporting the column foundations was eroded, resulting in a final scour
470 depth of approximately 1.1 m. A naval vessel was transported with the flow to higher
471 ground, indicating inundation heights of more than 3 m. According to Andiani et al. (2018),
472 the inundation depth was approximately 4.8 m at the Naval Base. Referring to Chapter 6 of
473 ASCE 7-16 (2017), a maximum scour depth of 3.66 m is reached when the inundation
474 depth exceeds 3.05 m. The scour at this site is well within this ASCE 7-16 Chapter 6 (2017)
475 design limit.

477 *Figure 10: Effects of sustained flow scour around columns (a-c) in Watusampu and d) around the edge of a bottom slab in*
 478 *Loli Pesua. Red arrows indicate the approximate wave direction and yellow arrows show the likely flow path.*

490 Further scouring was observed behind the second row of columns in the building
491 structural frame (Figure 10 b). Scour around the columns enabled the flow to further
492 remove sediment under the bottom slab of the building. This bottom slab was made of
493 concrete and masonry infill, and was presumably not designed to resist its own self-weight,
494 so it suffered heavy damage when the supporting soil was removed.

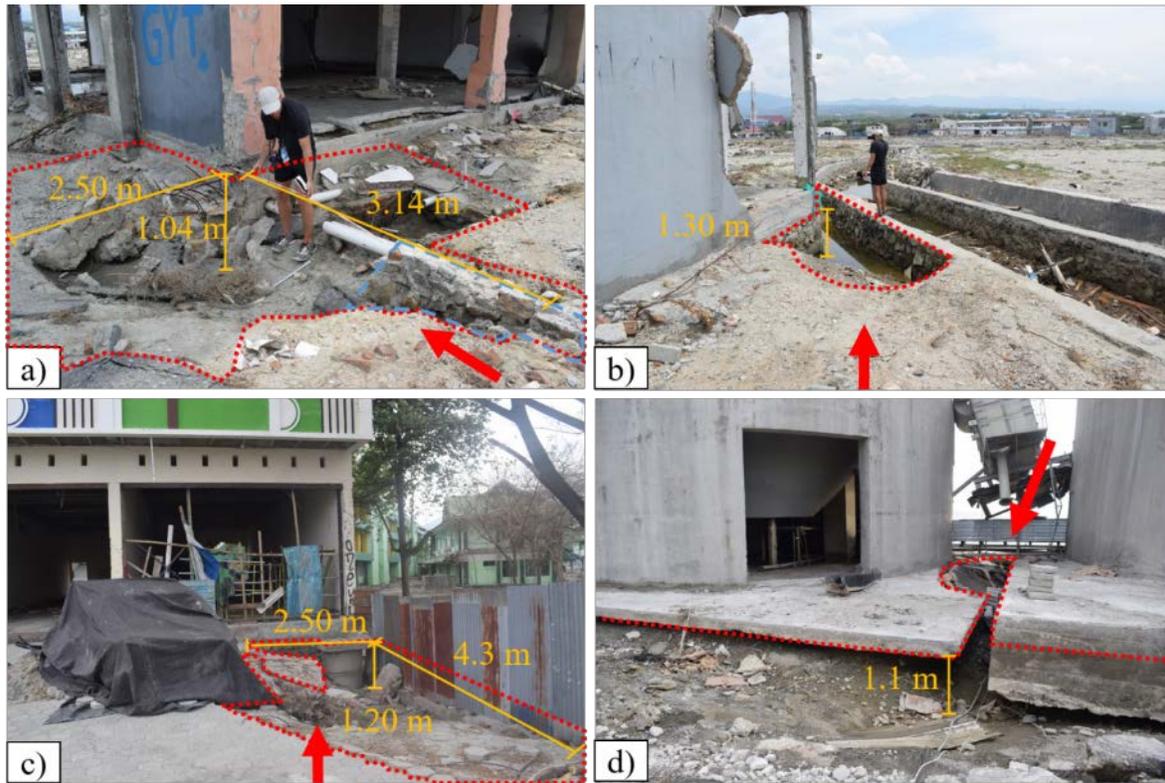
522 *Figure 11: Local and channelized flow scour a) on the northern and b) southern corner of the Shops at Palu Bay. c) Scour*
523 *besides a column foundation. The sheet metal wall on the right side replaces a masonry wall which was destroyed during*
524 *the tsunami. d) Scour around the silos of a cement packing plant north of Wani. Red arrows indicate the incoming*
525 *tsunami wave direction while the red dotted lines show the scour extent.*

526 Local scour in channelized flow conditions was observed on the north-west and on
527 the south-east side of the shops at Palu Bay. On the north-west, local scour around a

528 building corner was observed. A wall built on the seaward side led to high flow velocities
529 beside it (Figure 11 a), the wall is highlighted in ~~blue-black~~). The maximum scour depth of
530 1.04 m was found directly at the building edge, where the horizontal extent of the scour
531 hole was 3.14 m in the seaward direction and 2.5 m parallel to the coastline. Similar
532 processes can be seen next to the south-east corner, where an irrigation channel forced the
533 flow between the structure and the wall (Figure 11 b). In this constriction the flow induced
534 high shear stresses and thus an increased amount of scouring. The scour depth near the
535 foundation measured up to 1.3 m.

536 On the western side of a building next to the Institut Agama Islam Negeri (IAIN), a
537 sheet metal wall was constructed after the tsunami had damaged an earlier masonry wall
538 (which was washed away, along with paving stones in front of the building, see
539 Figure 11 c). In front of the foundation pile, the pavement was lifted and the underlying
540 sediment was eroded. The channelizing by the masonry wall (right side in Figure 11 c)
541 resulted in scour with a horizontal extent of 4.3 m in the seaward direction and 2.0 m along
542 the building edge. The maximum scouring occurred right in front of the foundation pile,
543 with a depth of 1.2 m.

544 At a cement packing facility about 30 km north east of Palu City concrete slabs
545 surrounding two silos were affected by scouring on the landward (Figure 11 d) and seaward
546 sides. The distance to the coastline prior to the tsunami was about 10 m. The scour between
547 the two silos on the landward side had a lateral extent of 2.8 m and a maximum depth of
548 1.1 m. As seen from the coastline, scour was also observed in front of the left silo, with a
549 lateral extent of 1.5 m and a maximum depth of 1.3 m. Eyewitnesses reported that the
550 initial separation of the connecting slab and tilting of one of the silos was caused by the

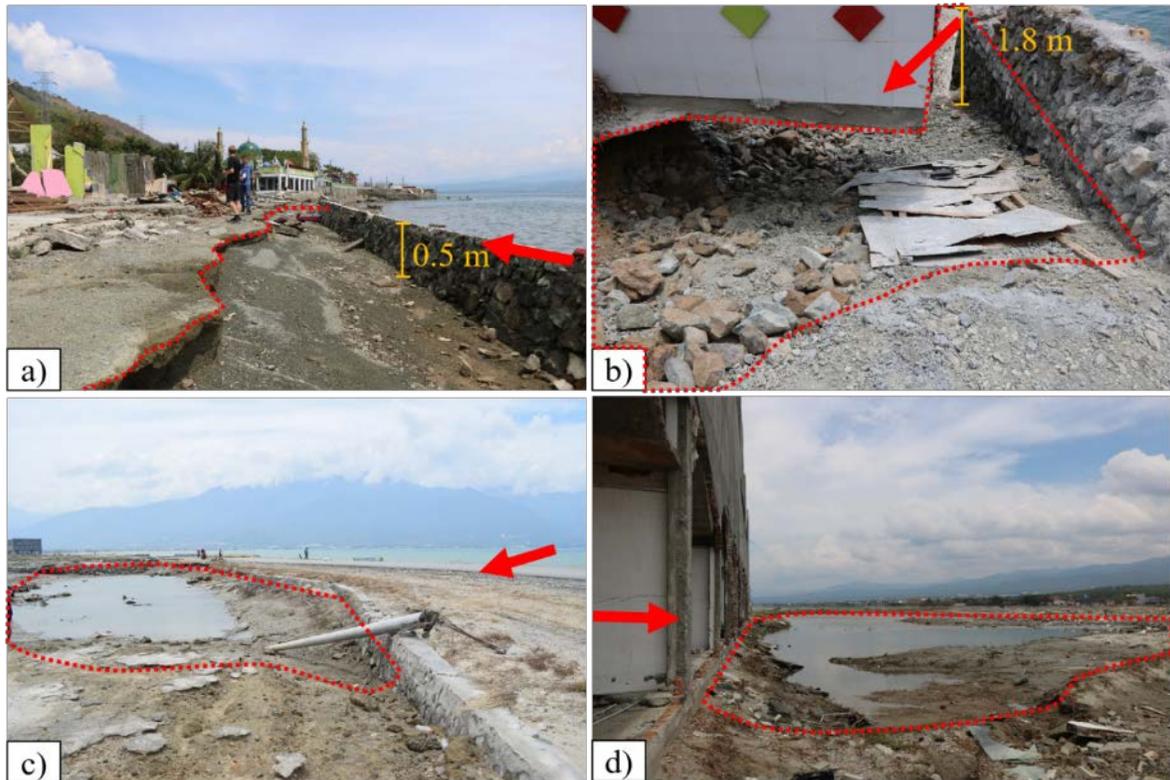
561 In Loli Dondo, a wall was built a few meters from the shoreline on the south side of the
562 mosque Masjid Ar-Rahman Loli Dondo (Figure 12 a). During the tsunami, the wall was
563 overtopped and the flow impinged on the soil behind, which caused plunging scour.
564 Besides the plunging scour effect, the tsunami draw-down might have also caused some of
565 this scour (when gravitational forces due to the scour hole accelerated the flow, which
566 could have resulted in a roller-like wave motion further eroding the inland side of the wall).
567 The scour occurred along the entire wall at this location, with a depth of about 0.5 m and a
568 length in the landward direction of about two to five meters.

570 *Figure 12: Plunging scour behind walls in Loli Dondo a) in the south and b) in the north. c) Plunging scour behind a*
 571 *retaining wall near a construction site and d) behind the shops at Palu Bay. The approximate scour extent is shown in red*
 572 *while the red arrows indicate the wave direction.*

573 North of the mosque in Loli Dondo, a circular wall was overtopped by the tsunami,
 574 and plunging scour led to sediment loss between the wall and a platform (Figure 12 b). The
 575 scour depth behind the wall was around 1.8 m resulting in the partial failure of the wall and
 576 in a large amount of eroded sediment, which was meant to support the platform. The
 577 sediment was wide-graded and mostly broken pebbles **gravel** ($d_{50} = 1-4$ cm). Similar
 578 processes to those described earlier might have been involved in this site, with the initial
 579 wave plunging to the backside of the wall, scouring the area behind it and leading to the
 580 saturation of the soil beneath. Finally, the receding wave could have taken the saturated
 581 sediment water mixture with it, with a roller-like wave motion enhancing sediment
 582 transport.

583 Around the shops at Palu Bay in panel c) and d) of Figure 12, general erosion,
584 sustained flows and plunging scour could be observed. These shops were situated at
585 distance of 30 m from the coastline, at an elevation of 4 m above sea level. After the
586 incoming tsunami propagated through the shops in Figure 12 d), the water plunged down
587 and scoured the soil behind the shops. No information about the terrain elevation prior to
588 the tsunami could be found.

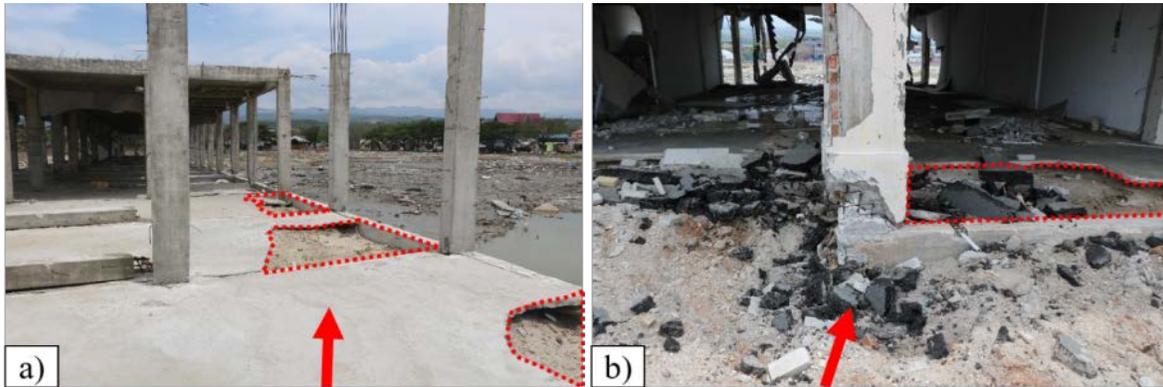
601 On the east side of Palu Bay, **approximately 5 km north of Palu City, the survey team**
602 **surveyed a construction site located 30 m from the shoreline** (Figure 13 a). Scour under the
603 slab-on-grade was observed at various locations in the building, as high velocity flows
604 passed over the structure and plunged down. This could have induced negative pressures on

605 the slab-on-grade and in the soil due to the presence of joints between the slab and edge
606 beam, which induced uplift and led to the failure (refer to Figure 2).

608 *Figure 13: a) Scour under the slab of a construction site on the east side of the bay in and b) scour in front of a column*
609 *and under the slab of the shops at Palu Bay. Red dotted lines indicate the areas of interest while the red arrow shows the*
610 *approximate wave direction.*

611 Scour underneath foundations was observed at the shops at Palu Bay (Figure 13 b).

612 Similar to the case of the construction site, the sediment underneath the slab could have
613 been pressurized by the flow separation after passing the slab edge beam. Figure 14 shows
614 a sequence of the possible process of the damage that could have lead to the failure of the
615 slab in Figure 13 b). Debris was found inside the building, which may have damaged the
616 tiles upon impact and thereby lead to a partially damaged slab. These debris were probably
617 asphalt pieces released from the street adjacent to the construction site and transported with
618 the flow. The water flow intruded into these partially damaged slabs, allowing for
619 pressurization or erosion of the supporting sediment, and led to further scouring. The
620 spatial extent of **damage to** the bottom slab ~~**destruction**~~ varied depending on the local
621 hydrodynamic conditions, which may be overlapped with initial **damage caused** by debris
