MONITORING OF POROUS ASPHALT AND ITS UNDERGROUND RESERVOIR AS A STORMWATER MANAGEMENT STRUCTURE FOR A PARKING LOT

Mémoire présenté pour l'obtention du grade de
Maître ès Sciences (M.Sc.)
En sciences de l'eau

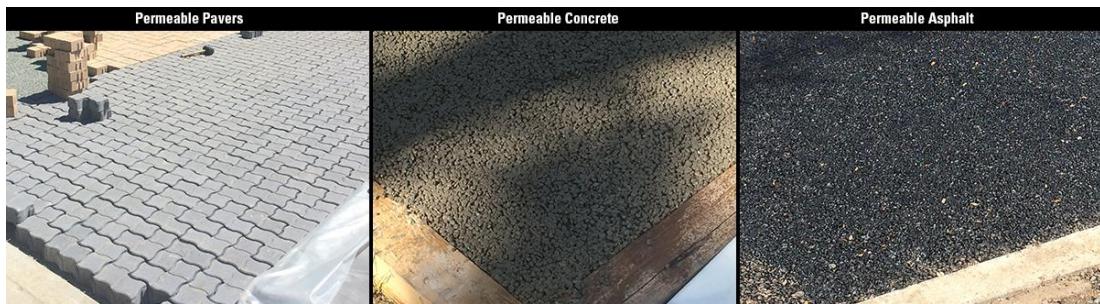
Figure 2-1 Different types of permeable pavements (Selbig & Buer, 2018)

Permeable pavements (PP) are stormwater source control infrastructure and are among the LID systems which help to decrease surface runoff to the sewer network, majorly through infiltration and storage. Runoff infiltrates through the pavement surface or joints of the pavement (in the case of interlocking concrete pavement) to an underlying temporary (i.e., vertical column) reservoir of high porosity packed materials and later infiltrates into the soil with or without geomembrane. PP are deemed sustainable not only for their structural, economic, and road-user advantages but also for their application in stormwater management (Singer et al., 2022). PP are suitable for residential roadways and parking lots and can be utilised on low traffic roads. Nevertheless, long-term performance as well as technical difficulties in installation and maintenance can hamper their full consideration as effective stormwater management systems for longer durations (Singer et al., 2022). They can be composed of different surface materials which define their permeability, such as concrete, asphalt, pavers, or grids, and can have various benefits and drawbacks depending on the context and design. In the context of this literature review, pervious asphalt (or permeable porous pavement), pervious concrete (or permeable concrete), and permeable interlocking pavement will be discussed. The surface pavement type or material for the different types of pavements is shown in Figure 2.1, taken from Selbig & Buer (2018).

1. **Porous asphalt (PA):** PA has a composition quite like that of CA, only with much less fines, thus creating a material with large porosity that allows water to infiltrate. PA has a higher void and porosity ratio than CA. Ahmad & Hafeez (2021) found that PA has a void space ranging from 15 % to 25 %, as opposed to 2 % for CA, and can provide additional water storage. However, the pores in PA are more prone to frost damage for some site conditions (Candra et al., 2020) and require careful design and maintenance.

2. **Permeable interlocking concrete paver (PICP):** This is made of interlocking concrete blocks or cobblestones with joints filled with porous media such as graded sand or gravel. Surface water infiltrates through the granular joints to an adjacent storage or soil beneath the pavement. This type of pavement is majorly used for driveways, walkways, parking areas, and low-traffic roads. It normally has a stone reservoir base that stores water and

3. **Pervious or porous concrete (PC):** PC is prepared with mixtures of cement and engineered coarse aggregates allowing for sufficient permeability, which guarantees stormwater to infiltrate to the underlying soil or reservoir layer. According to the Virginia Department of Environmental Quality (Virginia DEQ, 2011), the void created in the pavement is 15 % to 25 % of the total volume of the material.

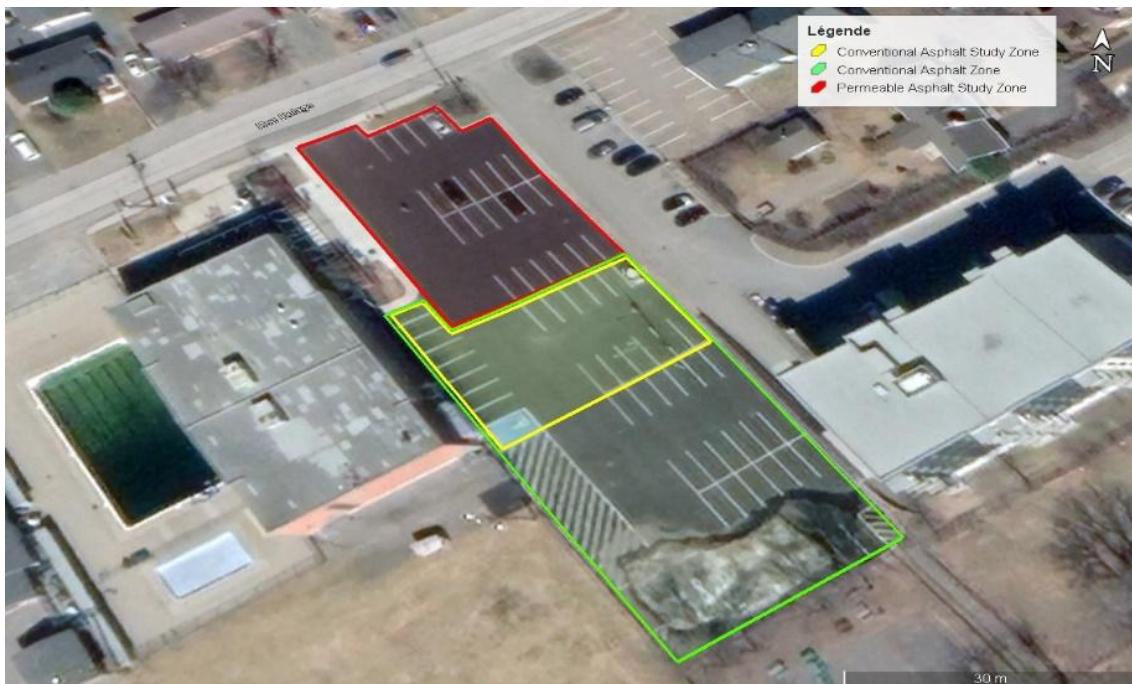
Figure 3-1 Parking lot specification: porous asphalt (red), conventional asphalt (yellow), and conventional asphalt not considered in this study (green)

The site, the municipal parking lot of Le Tournesol library, was initially fully CA. In October 2020, the site was reconstructed partially with PA by the MTMD. With this reconstruction, the 2300 m² CA lot was partitioned to create a drainage area of 854 m² made of PA (red perimeter in Figure 3.1) and 529 m² made of CA (yellow perimeter in Figure 3.1), together referred to as the study zone. The remaining portion of the CA, with an area of 917 m², shown by the green perimeter in Figure 3.1, is drained independently and not considered in this study.

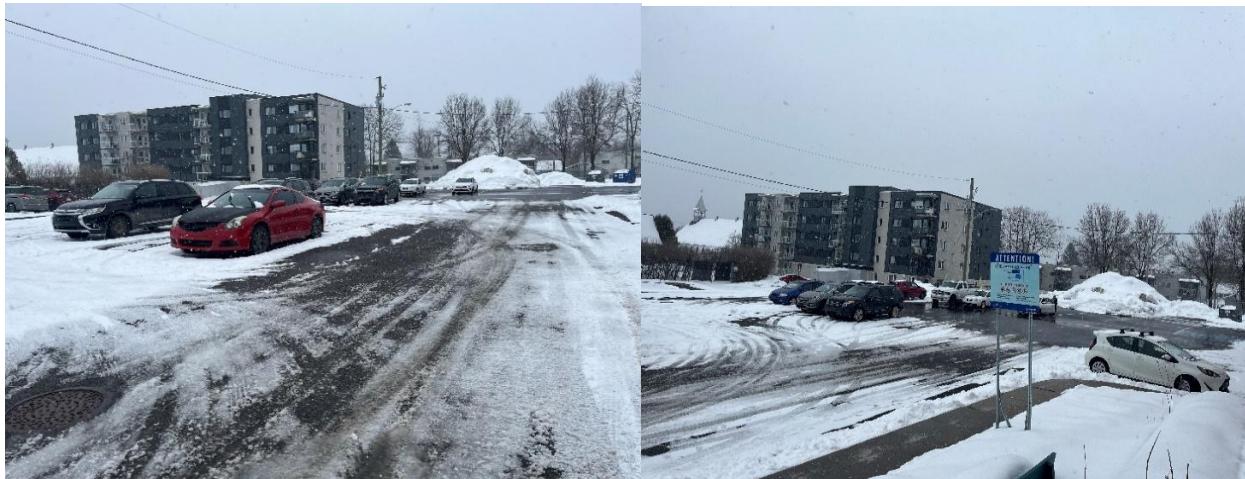
Figure 3-3 Signs of road salt or winter abrasives on the main driveway of the parking area (March 20, 2024)

neighbouring public parking lot and streets, traces of winter abrasives were left behind the main driveway of the parking area.

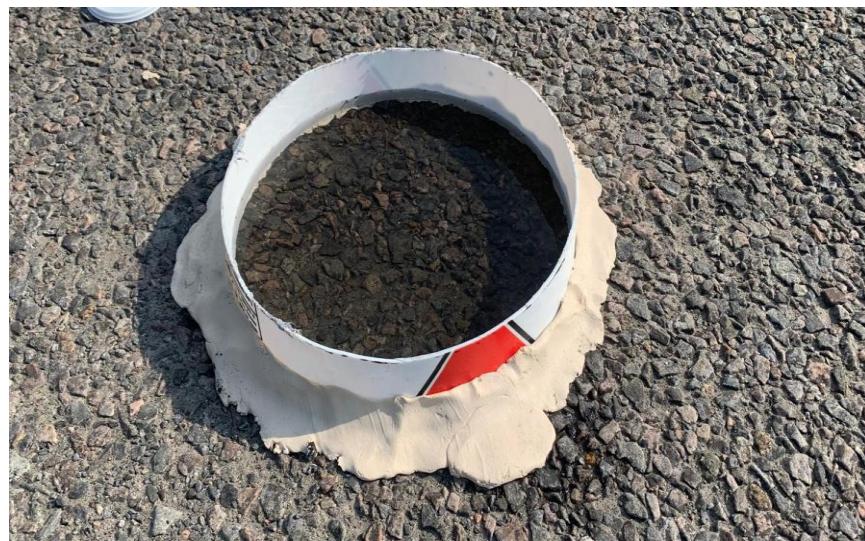
Figure 3-5 Measurement of infiltration rate of the porous asphalt according to ASTM C1781/C1781M-17a method

The surface IR was measured using the C1781/C1781M-17a standard of the American Society of Testing and Material (ASTM, 2015). In the 2023 season, the IR of the PA was determined on May 26, 2023, before summer cleaning/maintenance, and again on June 13, 2023, after cleaning. The IR tests were performed at the same discrete points as in Duchesne et al., 2022 (points 1, 2, and 3 in Figure 3.4) to compare the results over successive years. However, to adequately account for the spatial fluctuation of the IR, during the 2024 monitoring period, the tests were conducted in three more discrete points (see points 4, 5, and 6 in Figure 3.4) on May 21, 2023 and June 13, 2024. Points 2 and 4 are on local lanes, point 3 is on a parking lane, and points 1, 5, and 6 are situated along the main driveway leading to the parking lot. In addition, supplementary infiltration tests were performed at all six discrete points on July 19, 2024 and August 27, 2024 to further examine the clogging issue of the PA.

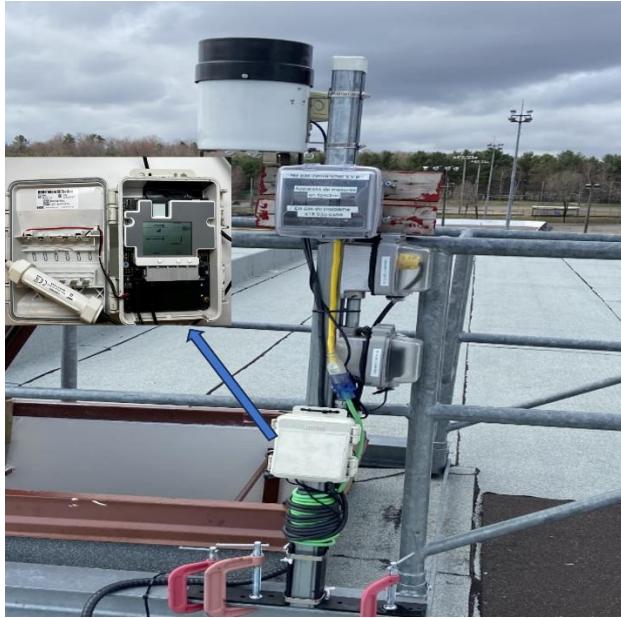
Figure 3-6 ONSET S-RGB-M002 heating tipping bucket rain gauge and the HOBO micro station data logger installed on the roof of the Le Tournesol library

An ONSET S-RGB-M002 heating tipping bucket rain gauge (Figure 3.6) was calibrated at the beginning of every monitoring period at the laboratory of Institut National de la Recherche Scientifique (INRS). For the calibration, 373 ml of potable water was allowed to drip from the bottom of a plastic container through the mesh area of the rain gauge. As stipulated by the device manual, a successful calibration is attained when the poured water produces 100 ± 1 tick (1 tick = 0.2 mm), in one hour. After the calibration, the rain gauge was installed on the rooftop of the library, located next to the site with a configuration to record data at a 5-minute interval. The data was transmitted wirelessly by a HOBO MicroRX station data logger. Rainfall data collection gaps were experienced throughout the monitoring period due to the rain gauge system malfunction and intermittent electrical breakdowns. Data were collected up until the beginning of the winter (November) and resumed at the end of winter (May). During the winter season, since most of the precipitation fell as snow, de-icing activities on the watershed were monitored instead.

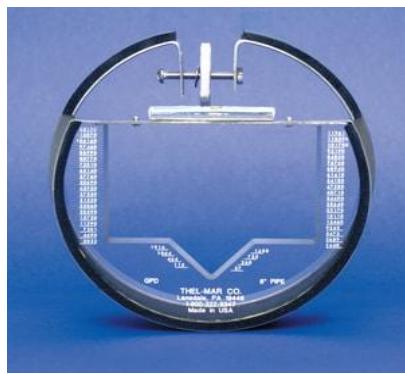
Figure 3-9 Thel-Mar weir (left) and HOBO MX2001 pressure probes (right) for flow monitoring

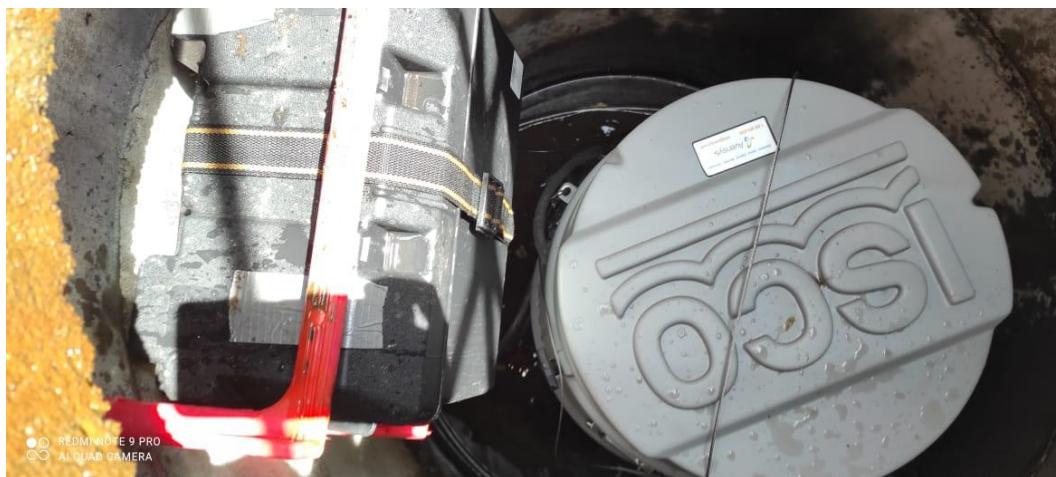
Figure 3-12 Autosampler installed in catch basin PU-2

A composite sampling method was adopted to sample runoff from the CA. This was achieved by installing an ISCO 3700 automatic sampler (Figure 3.12) in catch basin PU-2. After laboratory calibration of the automatic sampler at INRS, it was configured to sample 150 ml of water in each of the 24 bottles (Figure 3.13) at every 10 minutes. The automatic sampler had a moisture detector and suction line which were placed about 1 m upstream of catch basin PU-2 in pipe C2. Before the start of each sampled rainfall event, the 24 bottles in the automatic samplers were manually emptied, washed and placed in their positions. During rainfall, when water was detected by sensor in the pipe C2, the automatic sampler was triggered to collect water samples by the help of the suction tube. The collected samples were stored in the 24 bottles inside the automatic sampler. After mixing the contents of the 24 bottles, a single composite sample was taken to be analysed. All sampling bottles were cleaned prior to use to prevent external contamination.

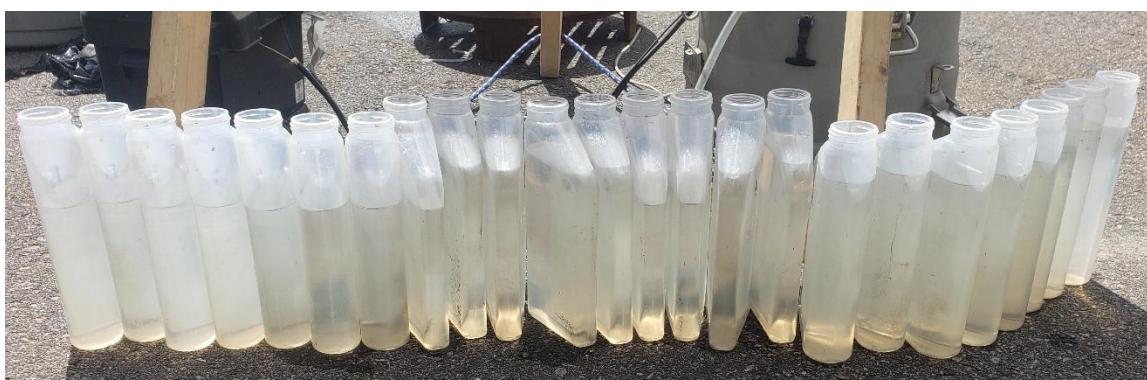
Figure 3-13 Automatic sampling from the conventional asphalt during a flow event

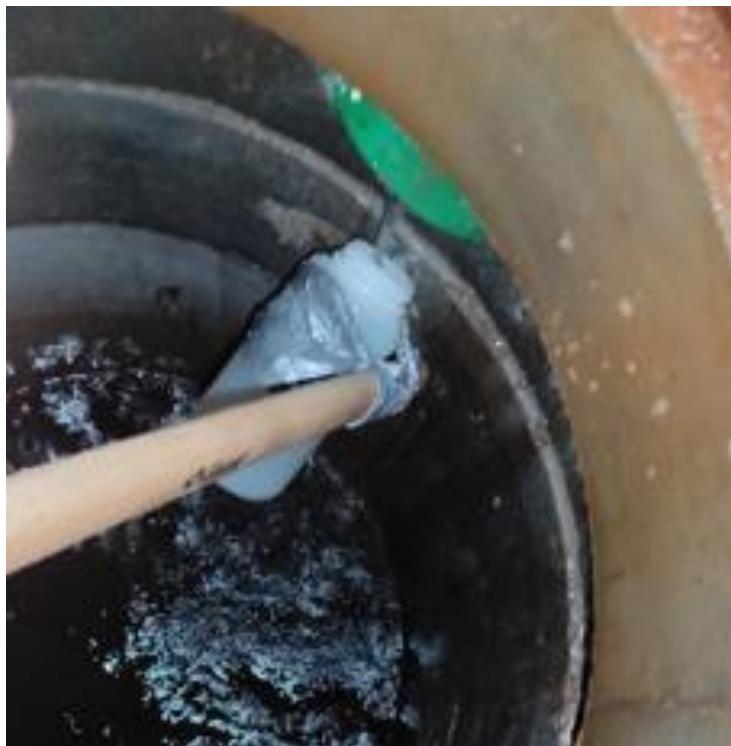
Figure 3-14 Manual sampling of water from the underdrain

As for the PA, the sample taken on the rainfall event of September 18, 2023, was collected as a single sample from the outlet of the PA underdrain (in catch basin PU-1) as shown in Figure 3.14, which was assumed to be representative of the water quality leaving the reservoir towards the municipal drainage system. Only one sample was collected during season 2023 due to absence of flow from the PA underdrain (except for September 18, 2023). This condition continued during the 2024 monitoring season even after surface cleaning of the asphalt. To compare the water quality of the PA and CA, for the event on June 23, 2024, samples were collected from the piezometer PZ-2 (see Figure 3.8) using a peristaltic pump (Geotech Geopump 2 model), as shown in Figure 3.15. For the August 10, 2024 event, the PA sample was collected in a depression located at the outlet of the underground drain. During this event, for which 81 mm of rain was recorded by the ECCC rain gauge, it is possible that water flowed through the drain. The water collected for the sample, after the end of the rain, is therefore most likely water that accumulated in this location during the rain.

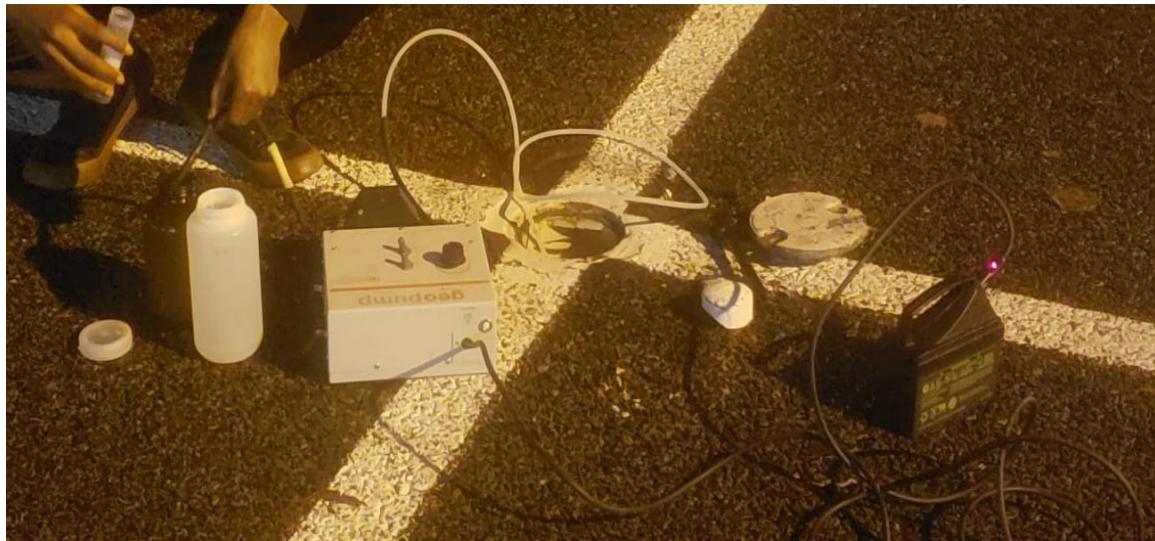
Figure 3-15 Sampling from the observation well (piezometer PZ-2) using a Geopump peristaltic pump from Geotech Environmental Equipment Inc

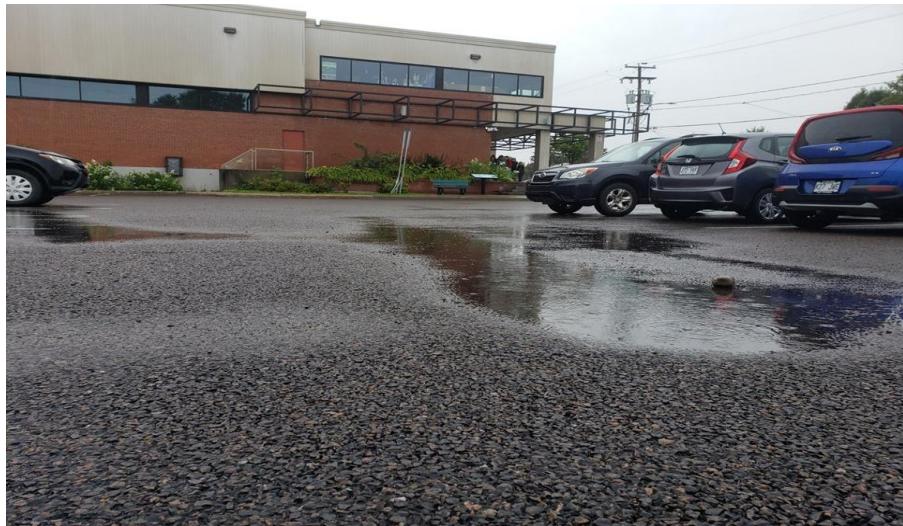
Figure 4-2 Surface water pooling on permeable asphalt (photographed on September 18, 2023)

May 2023), the average IR rate plummeted to 50 mm/hr, marking a drastic 98 % reduction of the value which was 2,237 mm/hr in April 2022. Following this sharp decline, the rate continued to decrease more gradually with minor fluctuations throughout the remainder of the monitoring period. This trend indicated the progression of asphalt clogging, which resulted in water accumulation on the surface of the PA, as illustrated in Figures 4.2 and 4.3. This suggests that the PA installed has not maintained its infiltrative capacity effectively over time. Selbig & Buer (2018) and Muttuvelu et al. (2024) revealed reductions in IR of 42 % and 92 % after three and nine years, respectively, following the initial construction.

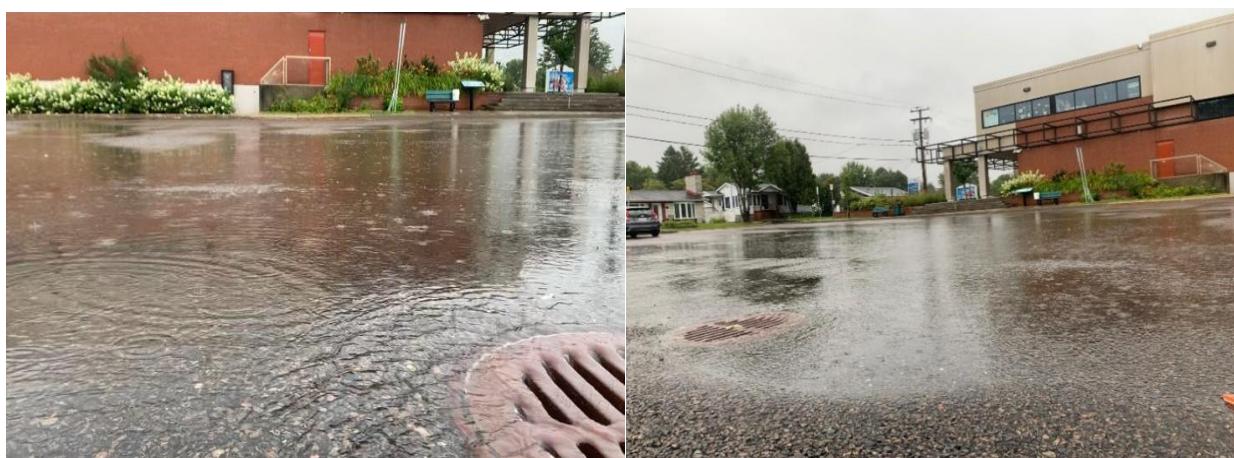
Figure 4-3 Pooling of water on the permeable asphalt surface (images captured on June 7 and 23, 2024, respectively)

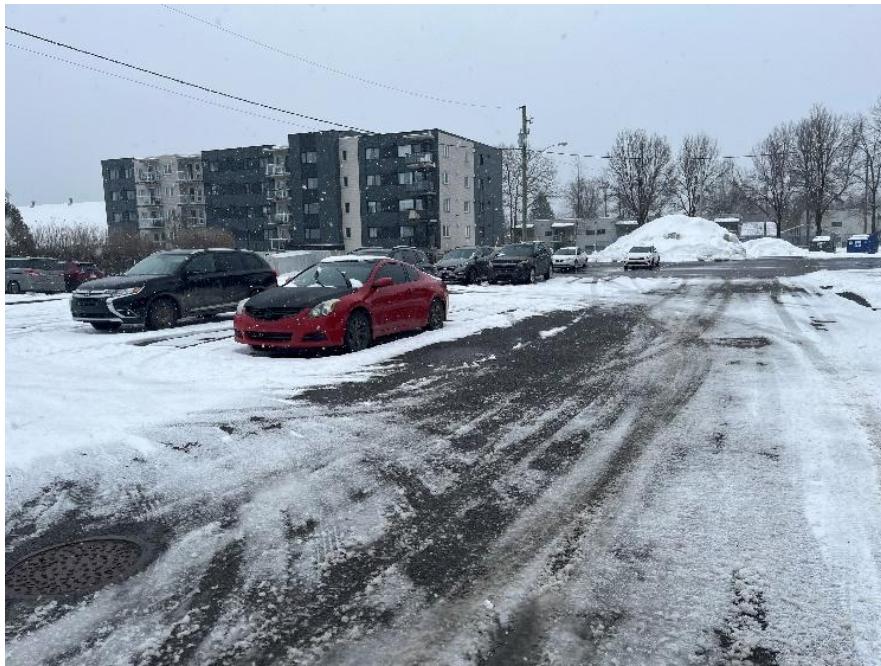
Figure 4-4 Sediment accumulation on the main driving lanes of the porous parking lot area

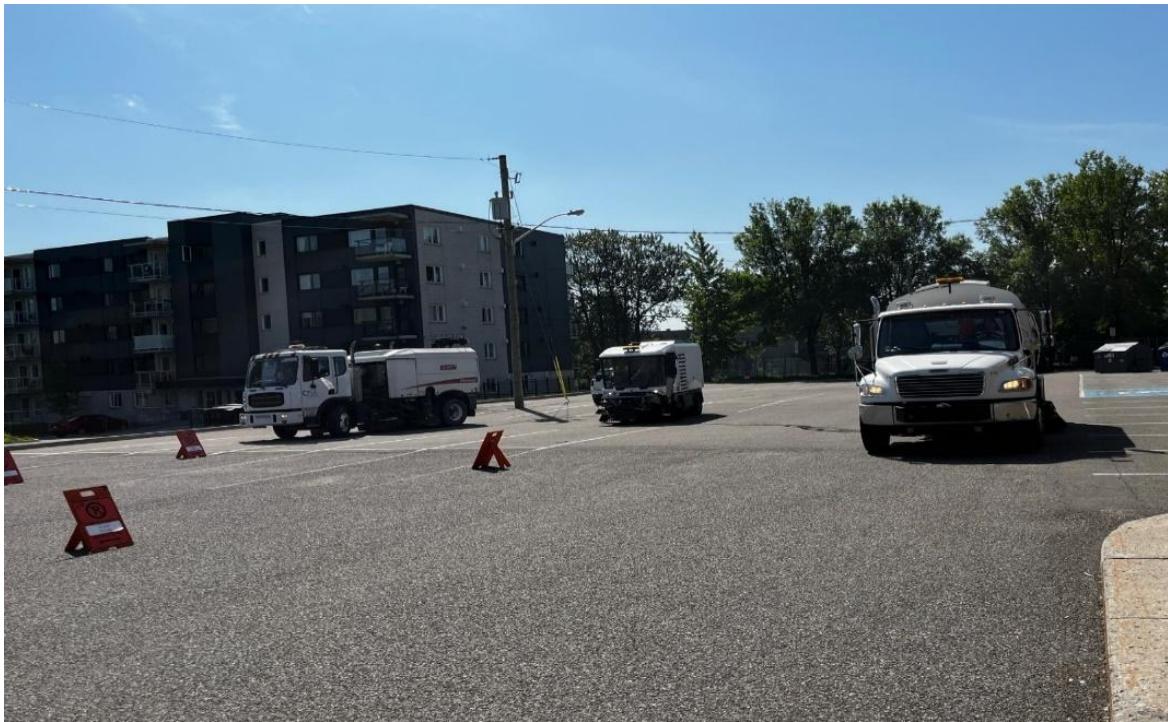
Figure 4-6 Site overview of the areas assigned to each vacuum truck during cleaning trials (left: Elgin Whirlwind; middle: Ravo 5; right: CityFant 6000)
