# Response of the Ha! Ha! River to the flood of July 1996 in the Saguenay Region of Quebec: Large-scale avulsion in a glaciated valley

M. F. Lapointe,<sup>1</sup> Y. Secretan,<sup>2</sup> S. N. Driscoll,<sup>1</sup> N. Bergeron,<sup>3</sup> and M. Leclerc<sup>2</sup>

**Abstract.** Modifications to valley form due to extreme flooding in the lower 34 km of the Ha! Ha! River were analyzed. Heavy regional precipitation in July 1996 triggered extreme runoff and the catastrophic drainage of Ha! Ha! Lake, producing discharges of 1100 m<sup>3</sup>/s, 8 times the 100-year flood. Dominant valley modifications, revealed by comparing pre-flood and post-flood topographies derived photogrammetrically, were related to two large-scale avulsions; in particular, a deep retrogressive incision which bypassed the 30-m-high Perron Falls, exporting  $6 \times 10^6$  m<sup>3</sup> of glacial stratified drift from a 2-km section of valley and producing massive sedimentation in the reach downstream. Reconstructed maximum flow power values support the existence of a 300 W/m<sup>2</sup> threshold for major scouring of the alluvial valley bottom. The evidence highlights the potential for massive scour and f

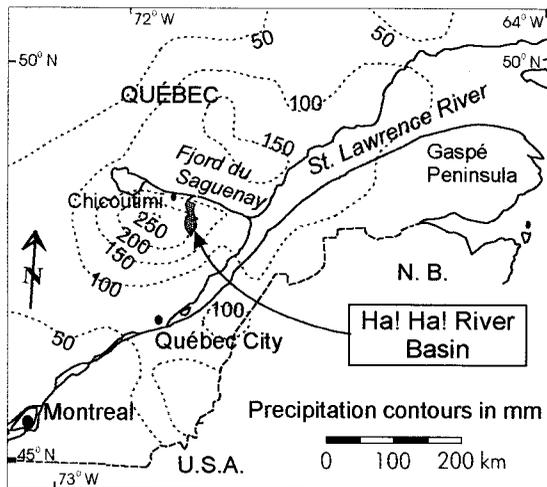
**Figure 1.** Forty-eight hour precipitation totals for eastern Quebec, Canada, from 8:00 a.m. July 19 to 8:00 a.m. July 21, 1996. The storm system triggered catastrophic flooding in the Ha! Ha! River basin, Quebec, Canada, as well as in basins throughout the Saguenay Region.

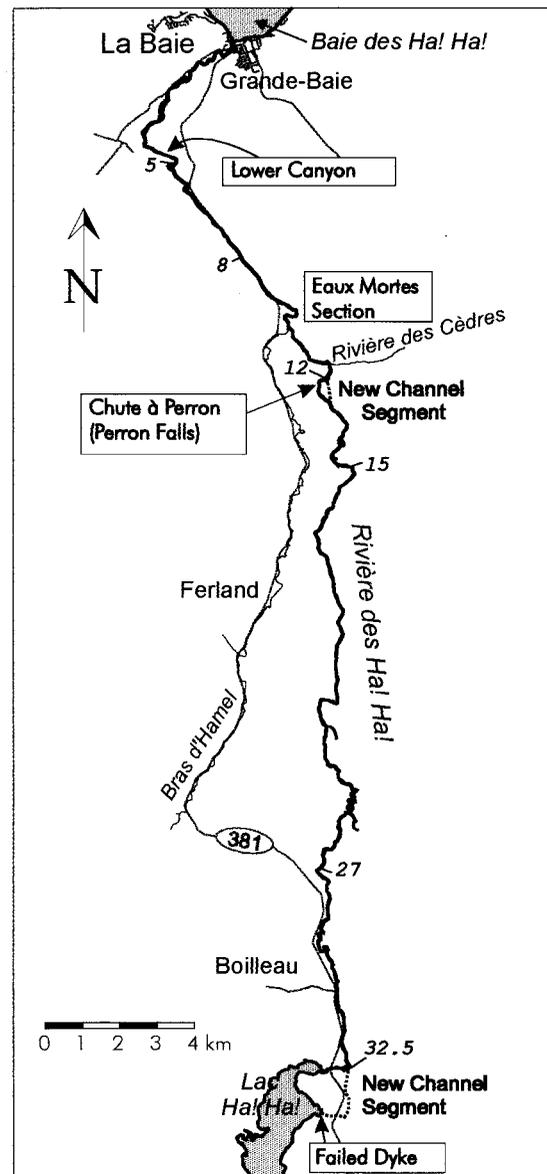
**Figure 2.** The Lower Ha! Ha! River, Quebec, Canada, along with tributaries and adjacent roads and towns. General characteristics of the various reaches are given in the text. Two new channel segments, scoured by the flood of July 1996, are indicated with dotted lines. Italicized numbers refer to river kilometer points discussed in the text.

connecting the failed dike to the previous lake outflow channel (see Figure 2). This channel incised vertically up to 15 m into the gravely sands underlying the forest, washing out a section of highway 381. Large volumes (quantified later) of sediment and forest debris were exported into the relatively low-energy, sandy Boilleau reach (gradient of 0.1%) immediately downstream (km 32.5–27). Sandy gravel accretion was most intense where the new channel joins the previous lake outflow (km 32.5), giving this sector a braided appearance after the flood. In the remainder of the Boilleau reach below km 32, the dominant modification was in-channel blanket deposition of sands, with overbank muds mantling village roads and surrounding farm fields. No cutoffs occurred in the preexisting meandering channel pattern; although, due to sand aggradation, the low flow channel became shallower with fewer pools. Except near a couple of debris jams, riparian shrubs and trees were left generally intact throughout this reach, albeit with decimetres of fresh sand accretion at their base. The lower limit of the Boilleau reach at km 27 is marked by bedrock outcrops on the valley floor, followed by a 15-m-high set of falls. This point marks the head of a 12-km-long reach (km 27–15) dominated by canyons and two other 20 to 40-m-high falls. Airphoto analysis indicates that this canyon reach underwent general scouring of the few extant patches of floodplain down to bedrock.

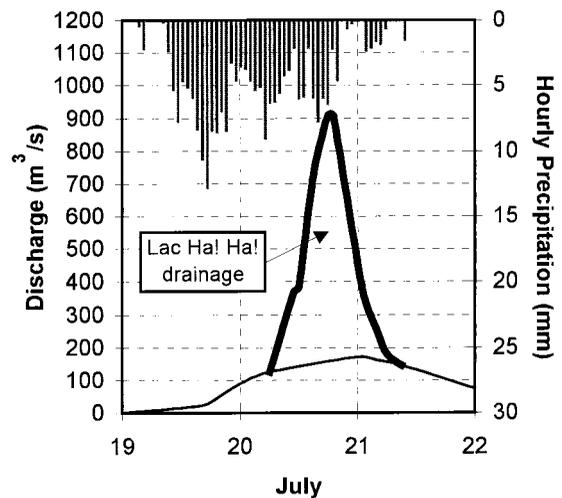
**Figure 3.** Reconstructed flood hydrograph at the outlet of Ha! Ha! Lake and hourly precipitation totals for the basin during the period July 19–22, 1996 [adapted from Government of Quebec [1997]]. The flows resulting from the catastrophic drainage of Ha! Ha! Lake are represented by the thick curve, superposed on the direct storm inflow to the lake.

For the Lower Ha! Ha! River the lake drainage component dominated the flood hydrograph (Figure 3), accounting for >80% of the peak flow of  $\sim 910 \text{ m}^3/\text{s}$  in the valley below the lake [Government of Quebec, 1997]. Discharges from tributaries, estimated by the runoff model, raised the peak flow estimate for the lower 10 km of the valley to approximately  $1100 \text{ m}^3/\text{s}$ , attained on the evening of July 20. At the basin mouth this peak discharge estimate, including reservoir drainage, corresponds to a specific discharge of  $1.8 \text{ m}^3/(\text{km}^2 \text{ s})$ . Historical gauge records show that, in the lower Ha! Ha! River valley, the mean annual flood is  $70 \text{ m}^3/\text{s}$  and the 100-year flood is  $130 \text{ m}^3/\text{s}$ . The catastrophic flow of July 1996 in the Lower Ha! Ha! River valley was thus over 15 times the mean annual flood and 8 times the 100-year flood.

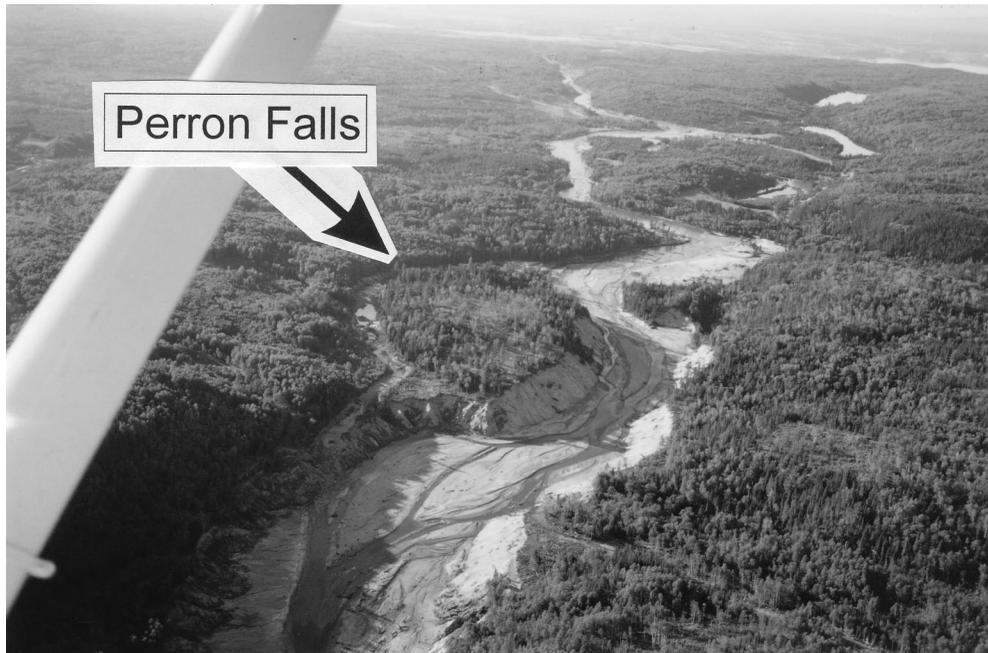
**Figure 4.** The Ha! Ha! River viewed downstream (northwards) towards Perron Falls after the recession of the extreme flood waters of July 1996. The flood triggered a large avulsion (foreground) which bypassed the 30-m rocky falls, located to the west (left) of a bedrock hill, vertically incising over tens of meters into glacial deposits. The low gradient Eaux Mortes reach appears in the background.

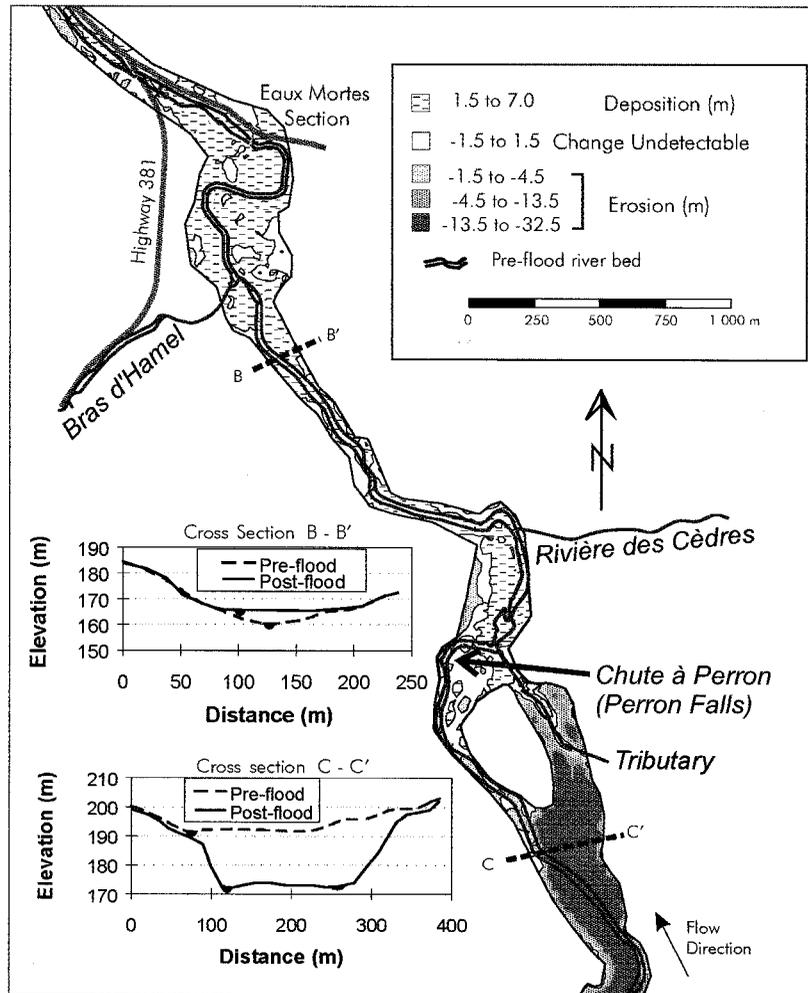
**Figure 5.** Valley modifications in the vicinity of Chute à Perron (Perron Falls) and the Eaux Mortes Section of the Ha! Ha! River, obtained by subtracting postflood from pre-flood valley terrain models, obtained photogrammetrically.

valley of a small tributary lying beyond the hill. This alternate flow path ran through an area underlain by sand-rich glacial deposits, tens of meters thick, which also extend up the Ha! Ha! valley over many kilometres. These stratified gravely sands are part of a late-glacial deltaic fill occupying part of the pre-glacial river valley. The fine texture of sediments underlying this side of the hill, in combination with the strong valley slope across the 30-m-high falls, led to the rapid 20-m vertical incision of a new 150-m-wide channel. This channel captured all the flood flow causing the river to rapidly avulse to the east side of the hill (Figure 4). In effect, because of extraordinarily high stages, the flood flows of July 1996 were able to reach an alternate path downvalley abandoning the bedrock control on which the post-glacial river course had become stuck at the Perron Falls. Figure 5 displays the valley modifications surrounding this avulsion, superimposed on the pre-flood course of the river and its tributaries. The striking effect of this avulsion on the river long profile in the vicinity of Perron Falls is also visible in Figure 6. Upstream of the avulsion, deep bed incision retrogressed over 2 km into the fluvio-glacial sand fill before encountering a rocky rapids section, near km 15. Downstream of the avulsion, the low-energy (gradient of 0.1%), partly meandering Eaux Mortes reach experienced massive

sand accretion (Figures 5 and 6). Blanket aggradation on the channel bed and surrounding floodplain averaged as much as 3 m. Parked vehicles and house foundations were buried in flood sediments, and three bridges were washed out in this reach.

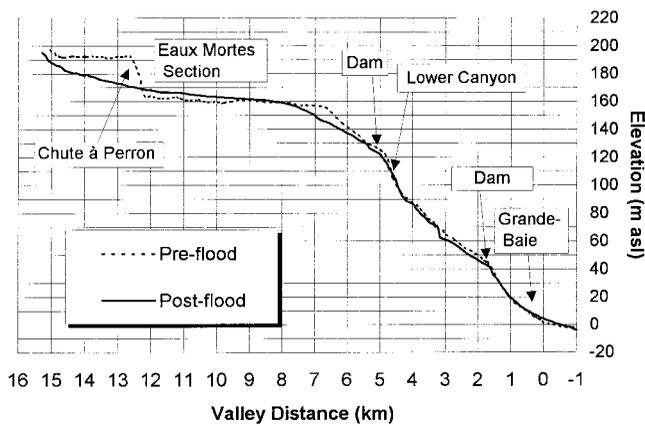
**Figure 6.** Preflood and postflood long profiles of the section of the Lower Ha! Ha! River from upstream of Chute à Perron (Perron Falls) down to tidewater at Baie des Ha! Ha! (at km 0). Elevations are those of the low flow channel surface extracted from preflood and postflood terrain models.

Figure 6). Incision reached 5–6 m between bedrock outcrops at km 1.7 (the dam site) and at km 3.2, where a new 5 m high fall created a knickpoint in the postflood profile. The flood left an active channel zone with poorly sorted alluvial bars (gravels and abundant sands, embedded with boulders up to 1 m in diameter). Approaching Grande-Baie, lateral terrace retreat carried away numerous houses and farms which previously flanked the left valley wall. Overall, channel zone widening reached 250 m. The pattern of terrace retreat on alternating sides of the valley, indicated in Figure 8 as zones with 4.5 to 16 m of valley bed lowering, reveals the longer wavelength sinuosity of the high-velocity flood flow, compared to the tighter sinuosity of the original channel pattern (outlined). A considerable portion of the Grande-Baie section of La Baie, including residences, businesses, and bridges, was entirely washed out in this reach (Figure 9).

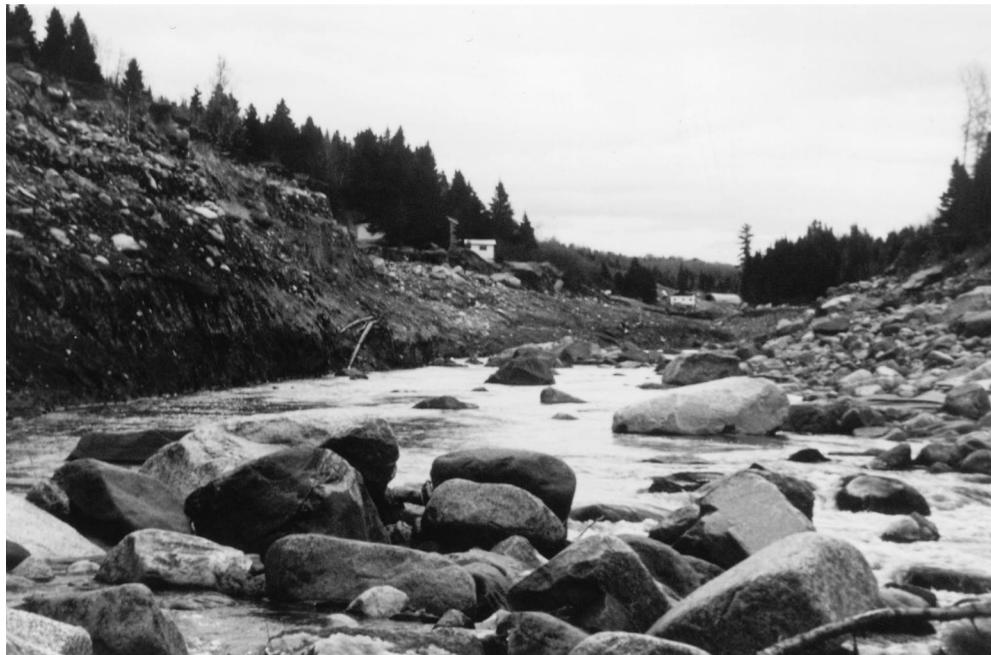
**Figure 7.** Upstream view of the Ha! Ha! River in the vicinity of km 7, after recession of the flood. Several houses and a section of highway on the right bank (left portion of photo) were carried away when floodwaters caused widening and up to 10 m of vertical incision, leaving behind a coarse bed armour (foreground boulders  $\sim 750$  mm) and oversteepened valley sides.

**4.1.3. Incision above the Lower Canyon (km 8–5).** Prior to the flood, the Eaux Mortes section was followed downstream by a higher-energy, bouldery reach (gradient of 1.7%) which extended through a relatively confined valley down to km 5, at which point the 200-m long, bedrock Lower Canyon controlled the valley bed elevation (Figures 2 and 6). During the flood, vertical incision occurred along much of this higher-energy reach. Incision also propagated retrogressively upstream to km 8, triggering considerable bed lowering in the lower 1 km of the low-gradient Eaux Mortes reach (Figure 6). Near km 7, the flood caused up to 10 m of valley incision, generally leaving a boulder pavement overlain with a lag of 2–3 m glacial drift boulders. Locally, incision in this reach also exposed bedrock and consolidated marine clay strata. Moderate valley widening accompanying this deep incision destroyed a section of road and most residential properties along a 2 km section adjacent to the right bank (Figure 7). Just upstream of

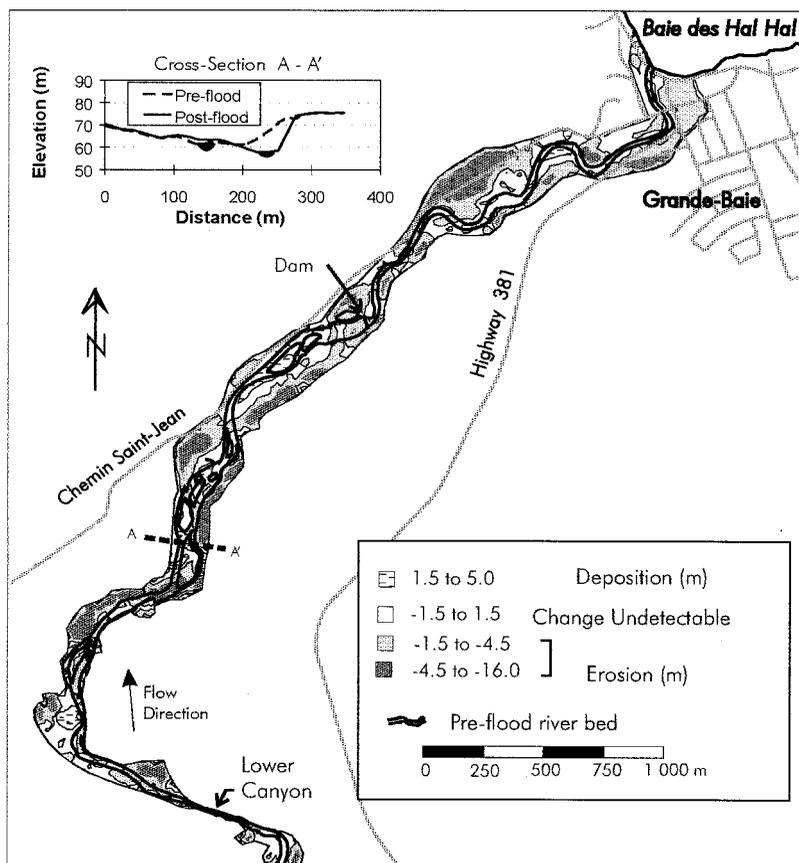
**Figure 8.** Valley modifications in the lower 5 km of the Ha! Ha! River, obtained by subtracting postflood from pre-flood valley terrain models, obtained photogrammetrically. Terrace retreat appears as patches of 4.5–16 m erosion.

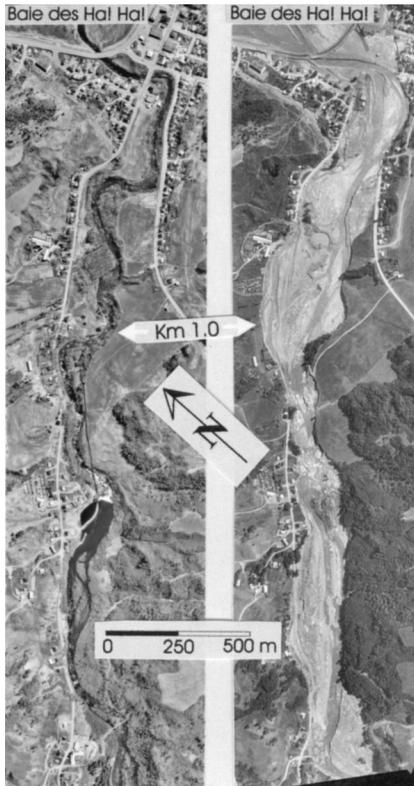
**Figure 9.** Aerial photographs of the lower 2.5 km of the Ha! Ha! River valley from May 24, 1994 (preflood; left) and July 30, 1996 (postflood; right). Considerable sections of the town of Grande-Baie (top of photos) and connecting roads were washed out during the extreme flooding of late July 1996.

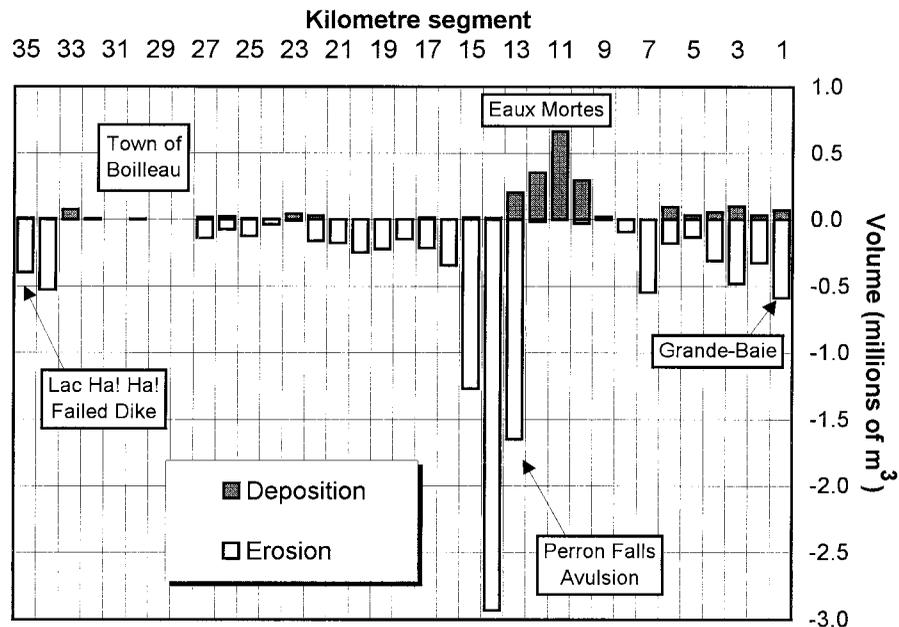
**Figure 10.** Net erosion and deposition in the Lower Ha! Ha! River valley due to the extreme flooding of July 1996, based on comparisons of preflood and postflood terrain models. Kilometre segments are numbered from the mouth (e.g., segment 1 refers to km 0–1). Segment 35 denotes the valley segment between km 34 and Ha! Ha! Lake (at km 34.3).

Figure 10 presents a distributed sediment budget, showing net erosion and deposition volumes for 1 km valley segments, calculated in the Modeleur as the difference in elevation between preflood and postflood valley geometries obtained photogrammetrically. Overall, valley scour was the dominant process. The avulsion at Perron Falls, with the retrogressive channel incision it triggered upstream (segments 13–15), was by far the dominant locus of scour, exporting approximately 6 million  $\text{m}^3$  of sediment downstream. Sedimentation volumes in the Eaux Mortes section (segments 9–12) were considerable (1.5 million  $\text{m}^3$ ) although much smaller than upstream scour volumes. A secondary locus of intense valley scour occurred upstream in the new channel section just below Ha! Ha! Lake (segments 34–35) which exported 1 million  $\text{m}^3$  of sediment downstream. Blanket sedimentation of fine sediments in the

Boilleau reach just downstream (km 28–32), although widespread, was under 0.25 million  $m^3$ . In the last 6 km of valley, leading down to tidewater, significant patches of accumulation occurred on the valley bottom but these were more than balanced by scour of the valley sides. A net total of over 9 million  $m^3$  were exported from the lower 34 km of the Ha! Ha! River valley and into the Saguenay Fjord. Assuming an average bulk density of 1.6  $t/m^3$ , this represents the export of  $\sim 15$  million metric tons of sediment, two thirds of which can be traced to the Perron Falls avulsion event. Despite the lack of historical sediment load data, an order of magnitude estimate of the pre-flood yearly sediment load at the mouth of the Ha! Ha! River can be attempted. Given a mean flow at the mouth of 8  $m^3/s$  and assuming a generous upper bound (100–500  $mg/l$ ) for the average (discharge weighted) yearly suspended sediment concentration in this boulder-dominated system, the annual sand export was at most in the range of 20–130 thousand tons. This is between two and three orders of magnitude less than the flood sediment export at the mouth due to the July 1996 flood (15 million cubic tonnes). Recent oceanographic surveys reveal that a multidecimeter thick wedge of sand and mud was deposited many kilometers into Ha! Ha! Bay by this flood.

Instead, large-scale deposition occurred on the bed and floodplain in both these low energy reaches (Figure 10). Both reaches received, within a few hours, millions of cubic metres of sandy sediment from the deep incision of new kilometer-long channels just upstream. In each case, the river avulsion and the incision of a new channel had been triggered by the extreme runoff event. At Perron Falls, the flood allowed the river to abandon a higher elevation section of valley on which glacial events had trapped it (Figures 4 and 6). At Ha! Ha! Lake, the dammed and heightened reservoir outlet was abandoned for a lower elevation outlet through a failed dike (Figure 2). In both cases, the new channel courses lay over easily eroded materials, highly susceptible to incision once exposed to large flows.

ticularly intense just downstream of a sudden valley expansion, due to a local amplification in flood energy gradient and flow shear stresses. At locations of valley expansion on the Lower Ha! Ha! River, such as near km 1.0 (Figures 8 and 9), clear patterns of enhanced local bed incision could not be detected. Instead, the entire lower kilometer of valley (i.e., kilometer segment 1) underwent catastrophic terrace retreat. This widespread erosion reflects the high level of peak stresses throughout the lower valley (350 to over 1000 Pa), much in excess of the threshold for floodplain stripping of 100 Pa suggested by Magilligan [1992]. As a result of this widespread erosion, the last kilometer of the Ha! Ha! River valley experienced a considerable export of sediment (0.5 million m<sup>3</sup> from km segment 1; Figure 10) during the July 1996 flood.

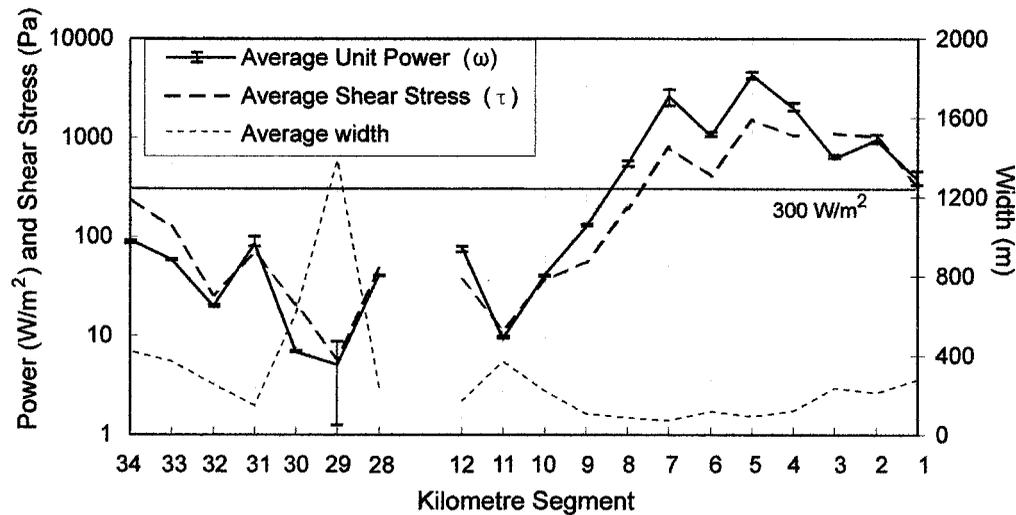
**Figure 11.** Estimates of Ha! Ha! River peak flood hydraulic parameters for 1 km valley segments. The plotted points for each parameter correspond to the average of two estimates, one assuming pre-flood topography and the other assuming post-flood topography. The range of these estimates is shown for flow power. The 300 W/m<sup>2</sup> power threshold is marked by a horizontal line. Kilometer segments are numbered from the mouth (e.g., kilometer segment 1 refers to km 0–1). Calculations of hydraulic parameters were omitted for segments 15–12, site of the Perron Falls avulsion and incision, due to the lack of water stage data appropriate to the valley incision phase. Peak stage data were unavailable for segments 27–16.

Figure 11 illustrates the downvalley variation in estimated peak stresses, flood powers, and flood-zone width. Error bars on the flood power estimates reflect the uncertainties about valley bottom geometry at the time of the peak flow (see Methods). By definition, shear stress and unit power are highly correlated variables and their overall patterns are consistent.

The most devastating flood powers ( $\omega$ ), ranging from 1000 to 4500  $W/m^2$  ( $\tau = 300\text{--}1500$  Pa) occurred in the steep and narrow valley sections from km segments 3–7. Except where bedrock dominated (km 3.2–4.7), this reach experienced up to 6–10 m of bed incision, combined with large-scale valley widening. The lack of data on the median sediment caliber for the highly unsorted bars in this reach precludes any detailed assessment of critical stresses required for entrainment of the coarsest boulders [Komar, 1996]; however, reconstructed shear stresses of the order 1000 Pa are clearly compatible with the transport of the metric boulders embedded in a sandy-gravel bar matrix. Within the low gradient Boilleau and Eaux Mortes reaches, where riparian vegetation was preserved and large-scale sand deposition was observed (Figure 10), peak flood power was almost two orders of magnitude smaller (10–100  $W/m^2$ ;  $\tau = 10\text{--}70$  Pa; Figure 11).
