1 **Engineering Lessons from the 28 September 2018 Indonesian Tsunami: Scouring**
2 **Mechanisms and Effects on Infrastructure**

91 A reconnaissance team led by the Waseda University, Japan, consisting of members
92 from Japan, USA, Indonesia, Canada and Germany, visited Palu Bay from the 27th to 31st
93 of October 2018. The objectives of this post-tsunami survey were to investigate the tsunami
94 generation mechanisms, to collect data concerning the flooding extent, and to reveal
95 knowledge gaps in tsunami-driven structural failure modes. The present work focuses on
96 the hydrodynamic loading and scouring around structures, comparing them with recent
97 tsunami design practices. The ultimate goal is to provide insights that tie knowledge from
98 the post-hazard survey to current design standards, and to specifically elucidate relevant
99 knowledge gaps pertaining to soil instability uncovered during the literature review, field
100 campaign, and analysis.

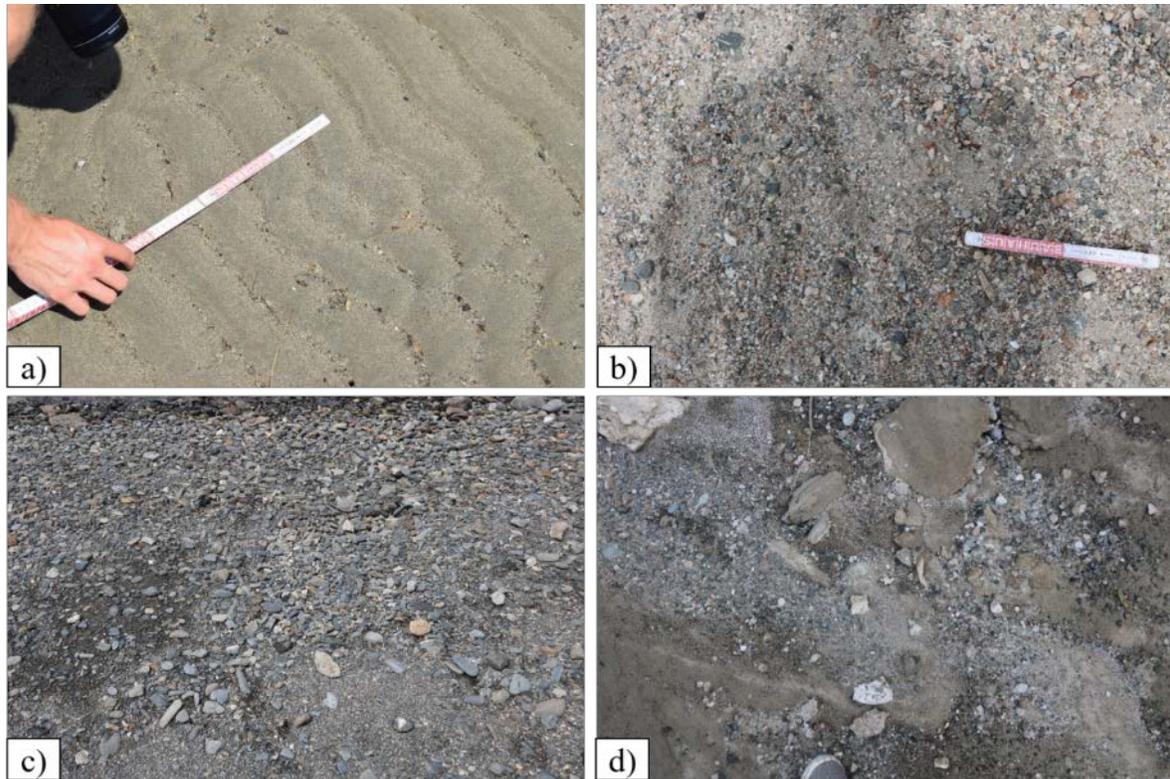
Soil material varied around Palu Bay depending on the location along the coastline and the distance to the shoreline. Figure 6 a) was taken in Palu west and shows fine sediment grains with a rather uniform diameter, while locations near a Palu City shopfront (b), Palu east (c) and Wani (d) show a wide-graded grain size distribution. Generally, the sediment material seemed to be fluvial material with round grains, rather than crushed material with sharp edges. **A visual inspection** of variation in grain size diameters could help explain some of the exposure and hiding effects discussed later in this paper. **However, no soil samples could be taken in this survey, which would allow for performing a sieve curve analysis and investigating soil effects more quantitatively.**

348 *Figure 6: Sediment types observed in Palu, Indonesia. a) A ruler was placed to obtain a rough estimate of the average*
 349 *grain diameter for Palu west, b) at a shopfront in the east of Palu, c) north of Talise Beach and d) in Wani.*

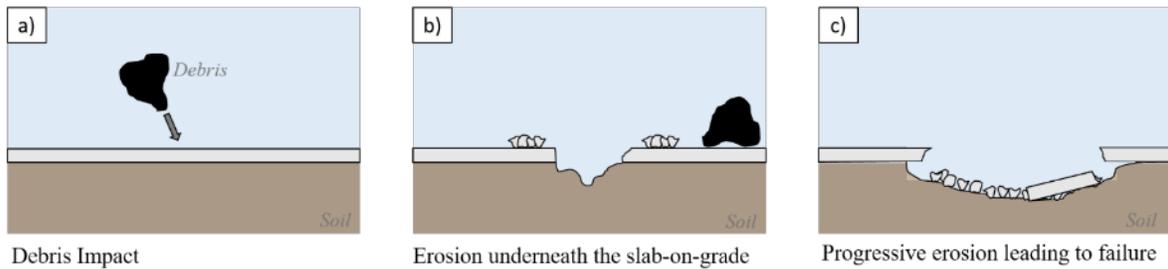
612 Similar to the case of the construction site, the sediment underneath the slab could have
613 been pressurized by the flow separation after passing the slab edge beam. Figure 14 shows
614 a sequence of the possible process of the damage that could have lead to the failure of the
615 slab in Figure 13 b). Debris was found inside the building, which may have damaged the
616 tiles upon impact and thereby lead to a partially damaged slab. These debris were probably
617 asphalt pieces released from the street adjacent to the construction site and transported with
618 the flow. The water flow intruded into these partially damaged slabs, allowing for
619 pressurization or erosion of the supporting sediment, and led to further scouring. The
620 spatial extent of **damage to** the bottom slab ~~**destruction**~~ varied depending on the local
621 hydrodynamic conditions, which may be overlapped with initial **damage caused** by debris

622 as entry points for scouring.

Figure 14: Combined loading of tumbling debris impact, sediment erosion and subsequent failure.
